# Training Bulletin

January 2013

## 2012 Plastic Tub Dishwasher Poor Wash Complaints

**Models: GDF510, GDF520, GDT530, GDF540 & GDF550**

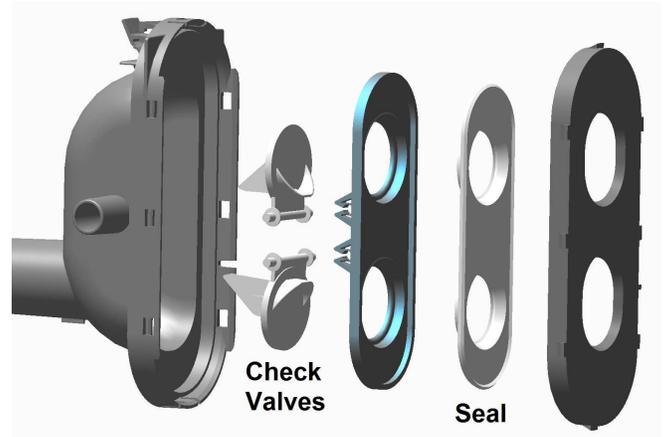
- Check the mid spray arm conduit seal and check valves for cuts, tears or other damage (can be done with conduit still on upper rack and no conduit dis-assembly), replace as needed. The mid conduit comes as a complete assembly.

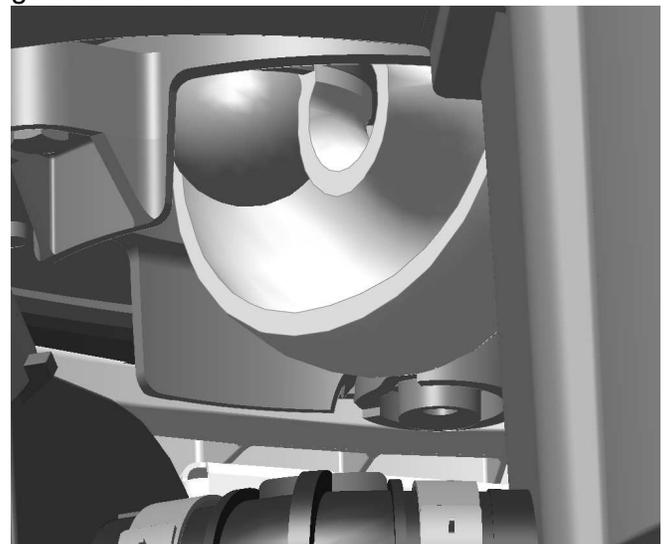
- If Spray arms are not alternating and all of the above are found to not be the issue, check the diverter check ball. A flashlight and inspection mirror may be used to view the diverter check ball. It may be stuck in the front or rear position. The ball should be at the bottom of the diverter during non operation. Shown in the below illustration, the diverter is sectioned with the ball in stuck in rear port. This would cause poor wash in the upper rack. The diverter is a translucent plastic, the check ball is orange in color and can be seen when an inspection mirror and flashlight are used. For full diverter operation explanation, please view service guide 31-9226.

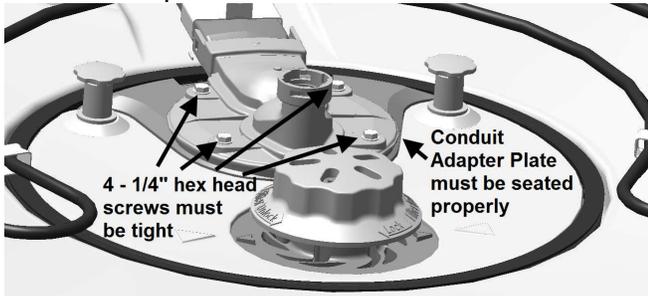
- Check the conduit adapter plate to verify it is seated properly and screws are tight or even missing screws. Re-install, tighten or replace needed components.

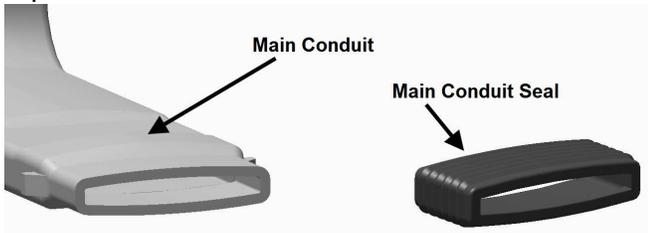
- Check the main conduit seal, damaged or missing, replace as needed.

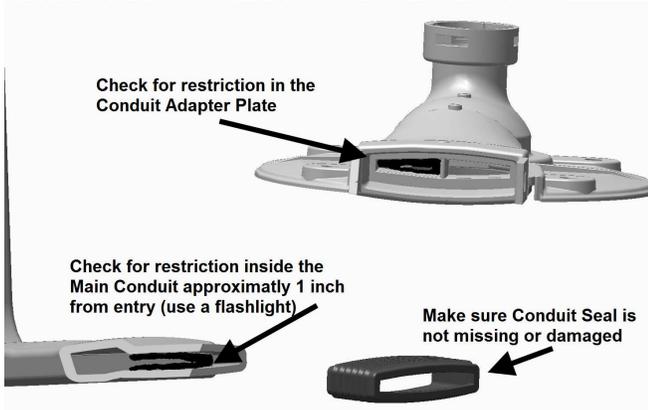
- Check Adapter plate and main conduit for restrictions, Remove the adapter plate to check, use a flashlight to inspect the main conduit, it may be restricted about 1 inch inside the conduit.

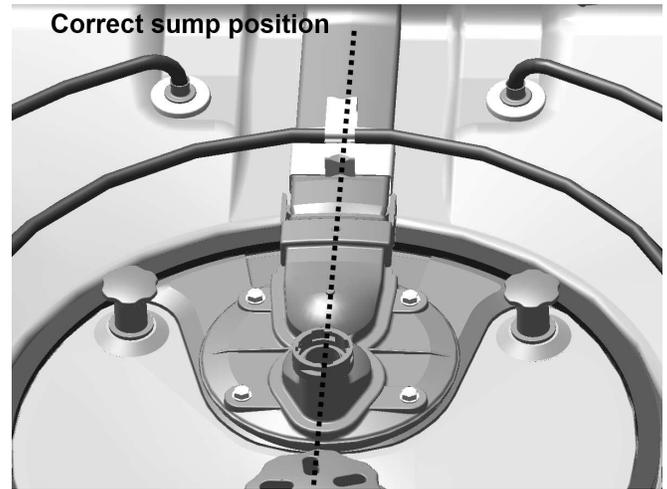
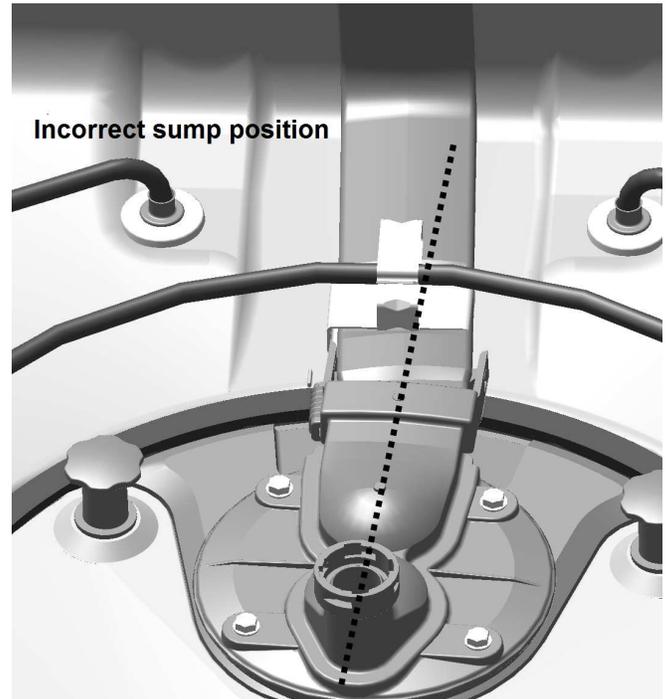
- Check for a poorly aligned sump module, this can cause a leak in the conduit adapter plate to the main conduit. This miss-alignment can cause leaks, low pressure to the upper spray system and not alternate spray to the upper arms. Sump will have to be removed and re-installed. Follow procedure in mini-manual or service guide
