# Training Bulletin

January 2013

## 2012 Plastic Tub Dishwasher Poor Wash Complaints

**Models: GDF510, GDF520, GDT530, GDF540 & GDF550**

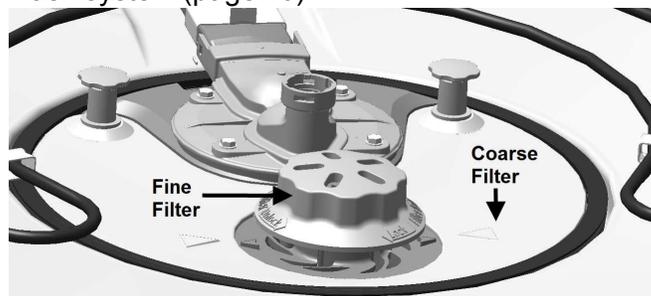
- Proper loading and adjusting of racks as discussed in the Owner's Manual, check for items blocking spray arms from turning (pages 8&9) and spray pattern.
- Cleaning filters, allows peak water flow through the wash system (page 10).

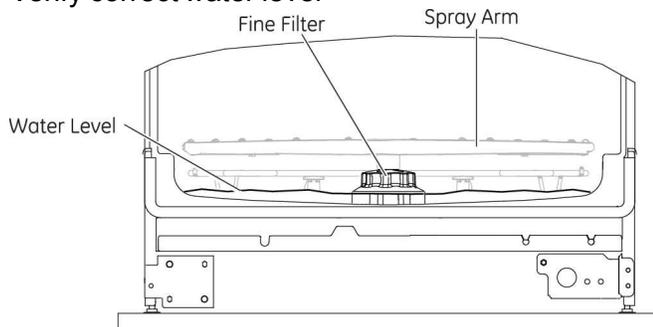
- Verify correct water level
